An Example from Mudanya Historical Houses: Examination of Reconstruction Works

Aylin ÖZODABAŞ¹, Moustafa KIOUTSOUK MOUSTAFA²

¹Bilecik Seyh Edebali University, Faculty of Civil Engineering, Bilecik, Turkey

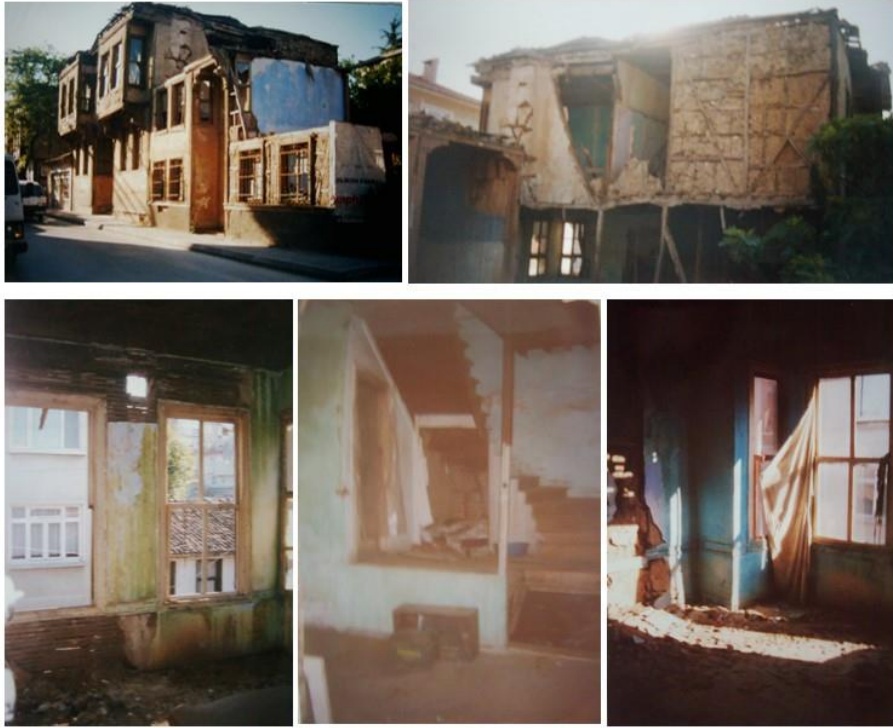
Figure 6. Restitution of buildings in parcel numbers 9 and 10

Most of the building has been damaged. As can be seen in Figure 6 particularly, most of the building and roof was collapsed and damaged there is in the parcel number 9. Over time, the buildings in both parcels disappeared. The survey drawings of the front frontages of the parcels 9 and 10 are given in Figure 7. As it can be seen from the front and rear frontage views given in Figure 8, it is understood that the structure located in parcel number 10 has lost its bearing characteristics.

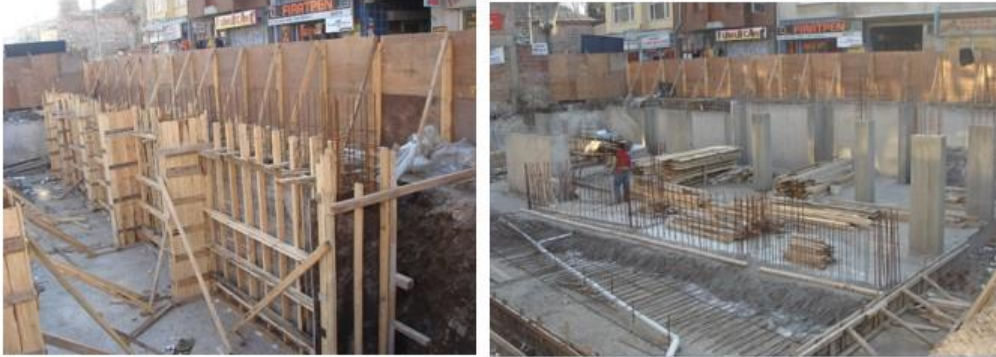
Figure 18. Construction of the foundation of parcels numbers 9 and 10

The foundations of the buildings in the parcel numbers 9-10-11-12 were built as a raft foundation. It is shown in Figure 18 and 19. The buildings in the parcels number 9 and 10 were built with the traditional timber frame method. It is shown in Figures 20. The buildings in parcel 11 and 12 were built as reinforced concrete. Because the historical structures that were previously here have completely collapsed and no data has been found. Therefore, in order to adapt to the street

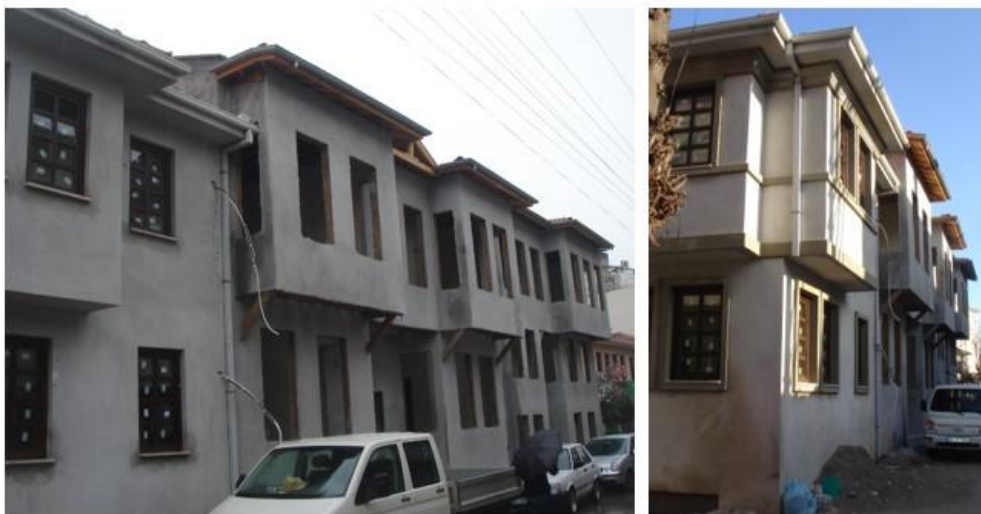
Figure 21. Reconstruction of the buildings

silhouette, a similar structure was planned and constructed as reinforced concrete. It is shown in Figures 21. Views of the floor and roof details of the buildings in parcels numbers 9 and 10, which were given made with the traditional technique, were given in Figures 22 and 23. Wastewater piping and heating system and power sockets are shown in Figure 24. Figures 25 and 26 show post-reconstruction pictures of the buildings.
